State of California
The Resources Agency
DEPARTMENT OF WATER RESOURCES
Northern District

SACRAMENTO VALLEY
WESTSIDE TRIBUTARY WATERSHEDS
EROSION STUDY
REEDS CREEK WATERSHED

OCTOBER 1991

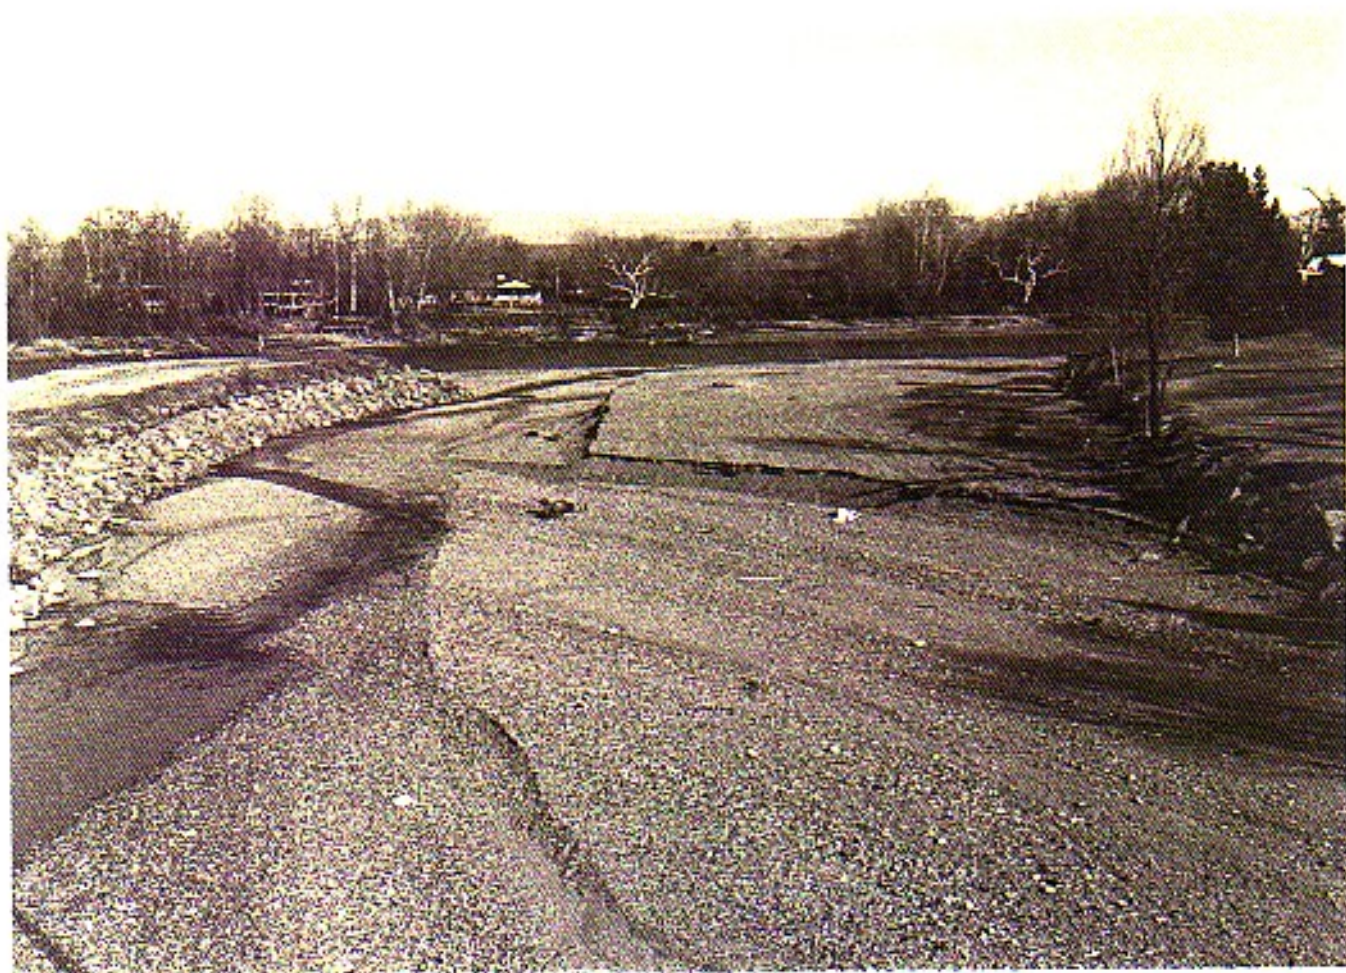
Photo 1. The confluence of Reeds Creek and the Sacramento River during the summer of 1986 was choked with sediment. The sediment stored here was the result of Lake Red Bluff backwater effects. The present operation of the dam includes raising the dam gates during winter months, allowing for the natural flushing of sediment into the Sacramento River, although a large amount of sediment still remains in the channel.

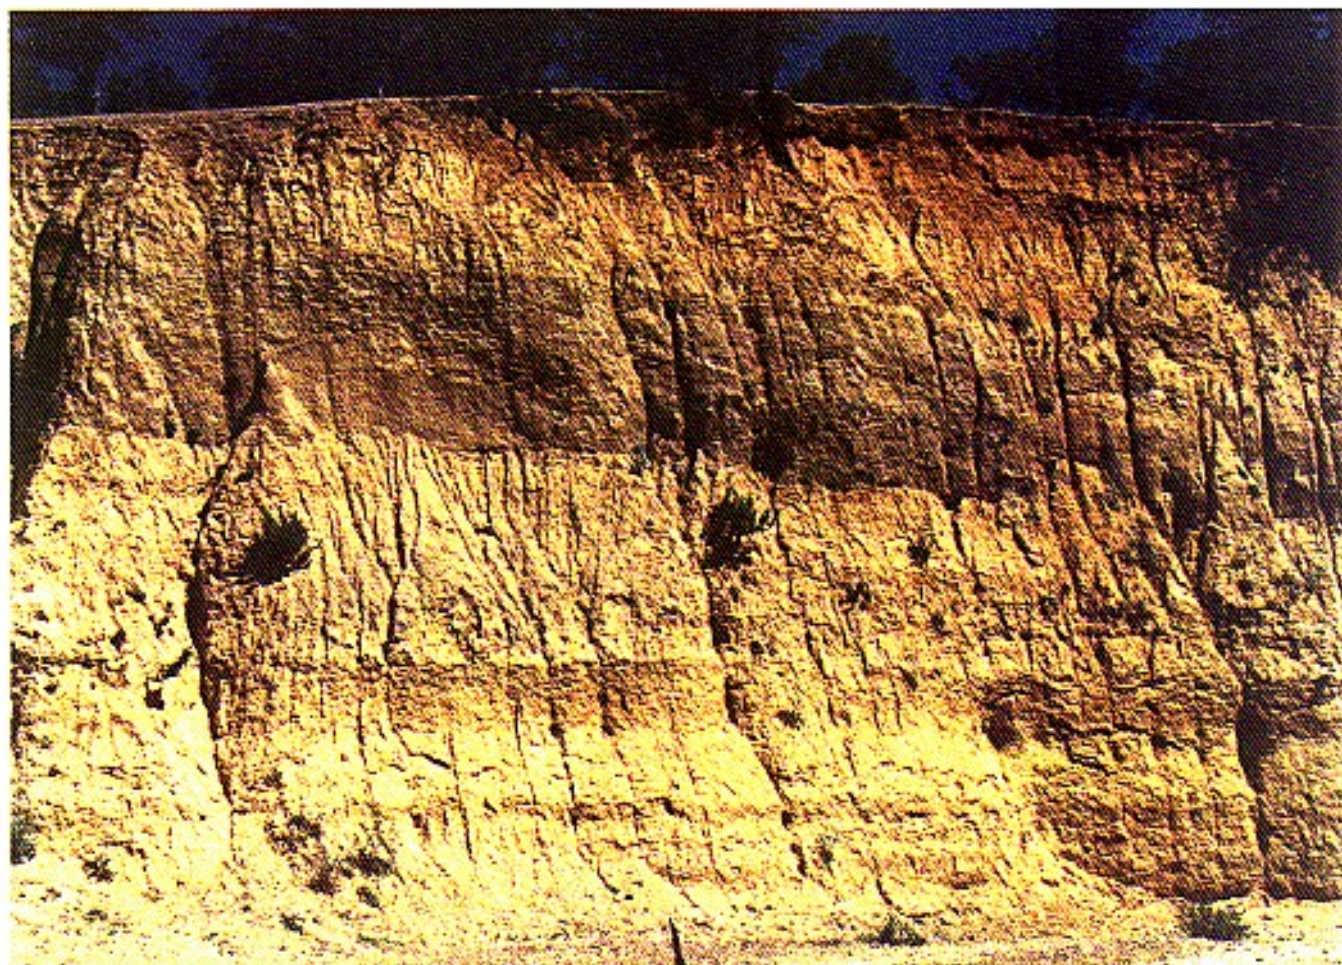
Photo 3. The fine-grained sedimentary deposits of the Tehama Formation are well exposed along Pine Creek.

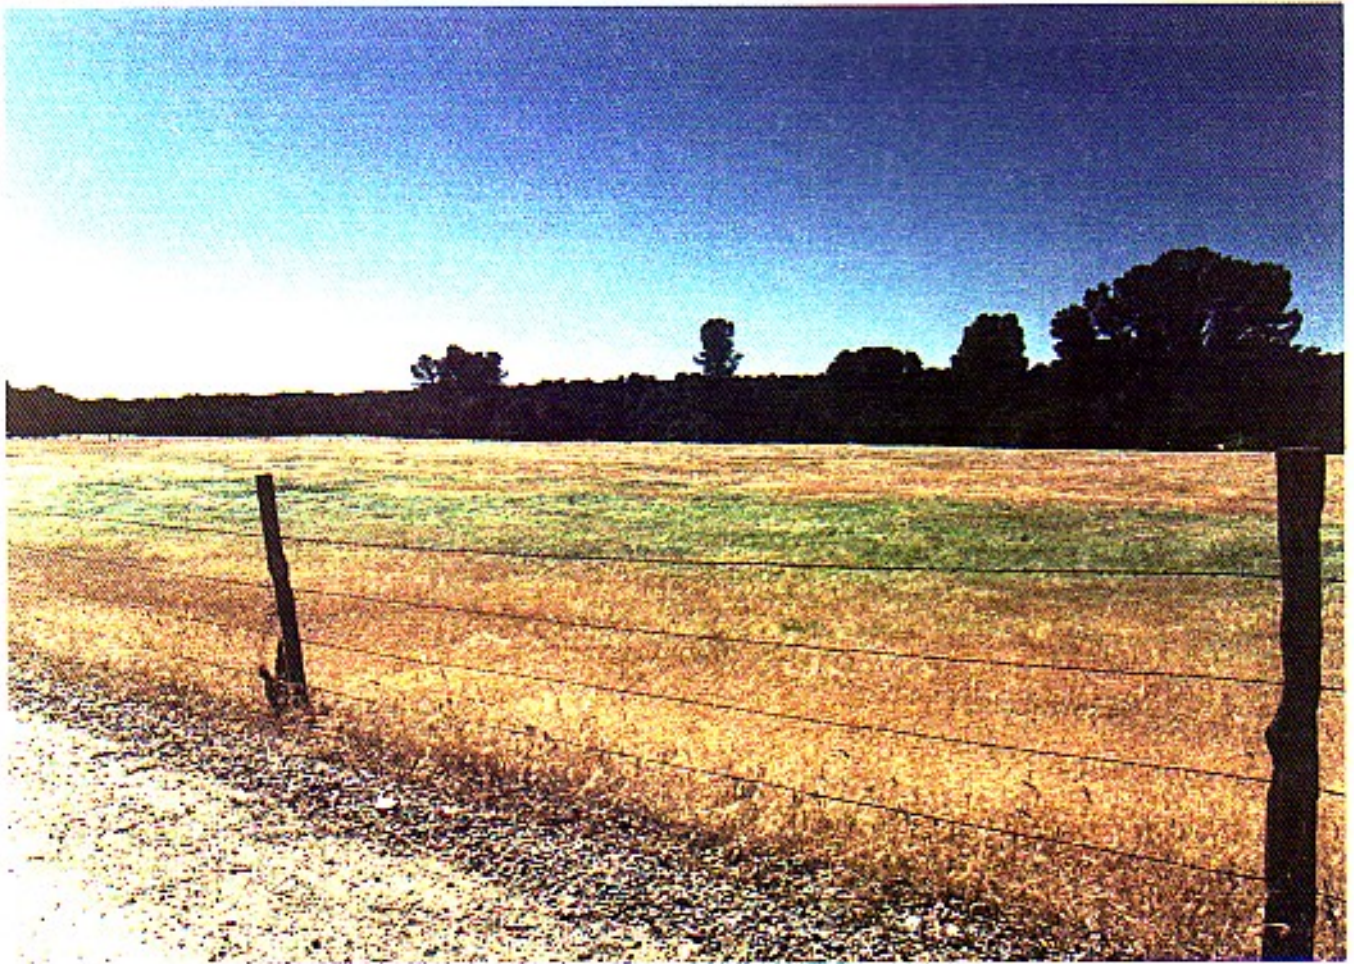
Photo 4. Upper Riverbank Terrace deposits such as this terrace in Burr Valley, are common.

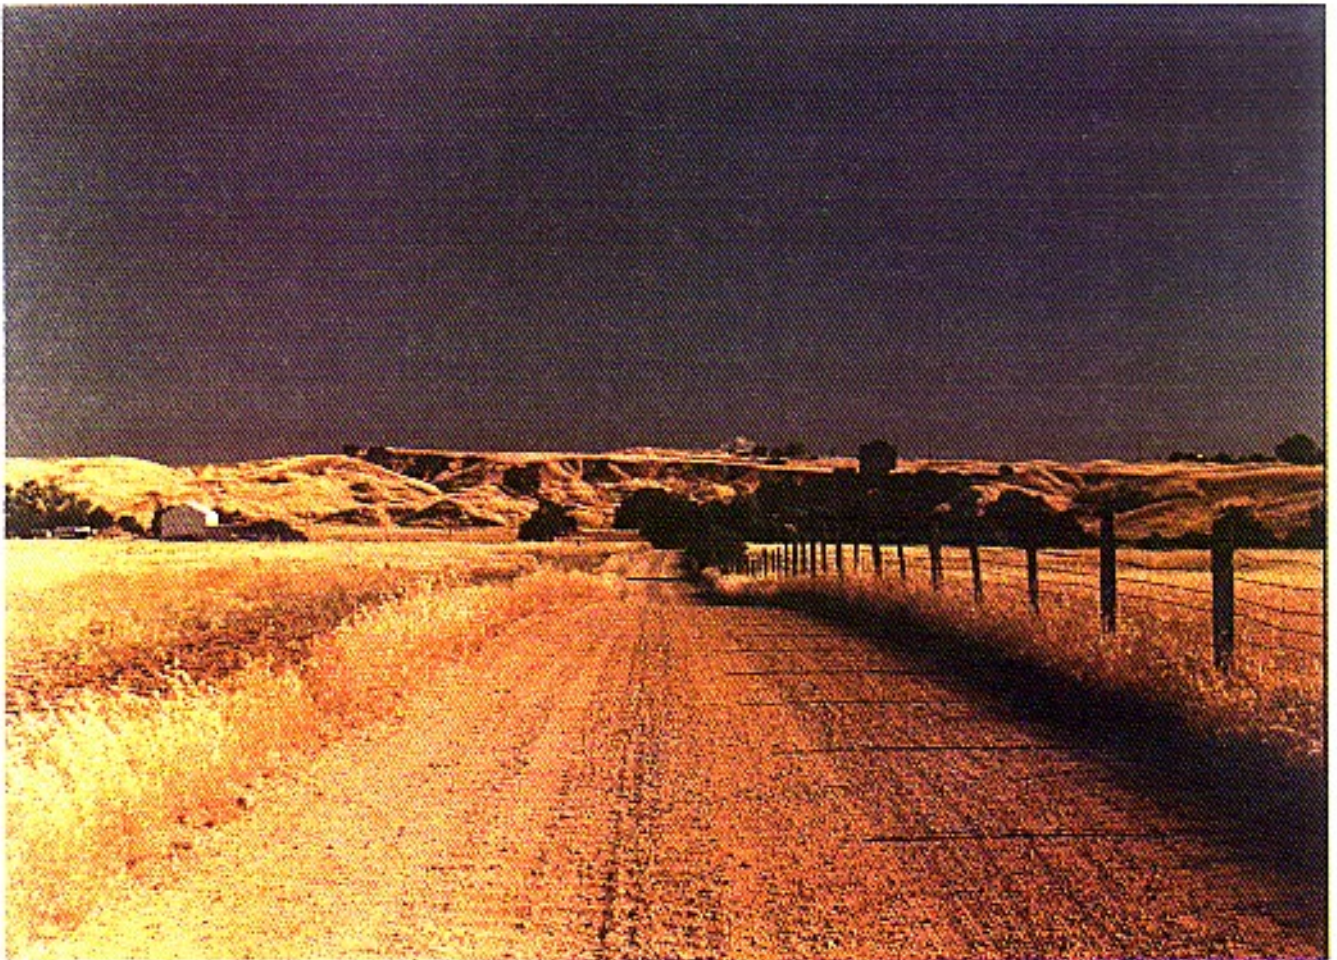
Photo 5. A large area of landslides occurs along Brickyard Creek in the Tehama Formation.

Landslides. Mappable landslides are rare in the Reeds Creek watershed. Analysis of 1988 aerial photographs revealed no large-scale slope failures or landslide deposits. Field surveys and analysis of 35mm color slides flown at 3,000 and 6,000 feet show that scattered, small-scale landslides occur, mostly near the crests of ridges above elevation 700 feet where the relief is steeper. These landforms have been plotted with the larger areas of actively eroding headcuts. One area on the north side of Brickyard Creek contains several large earthflows (Photo 5).

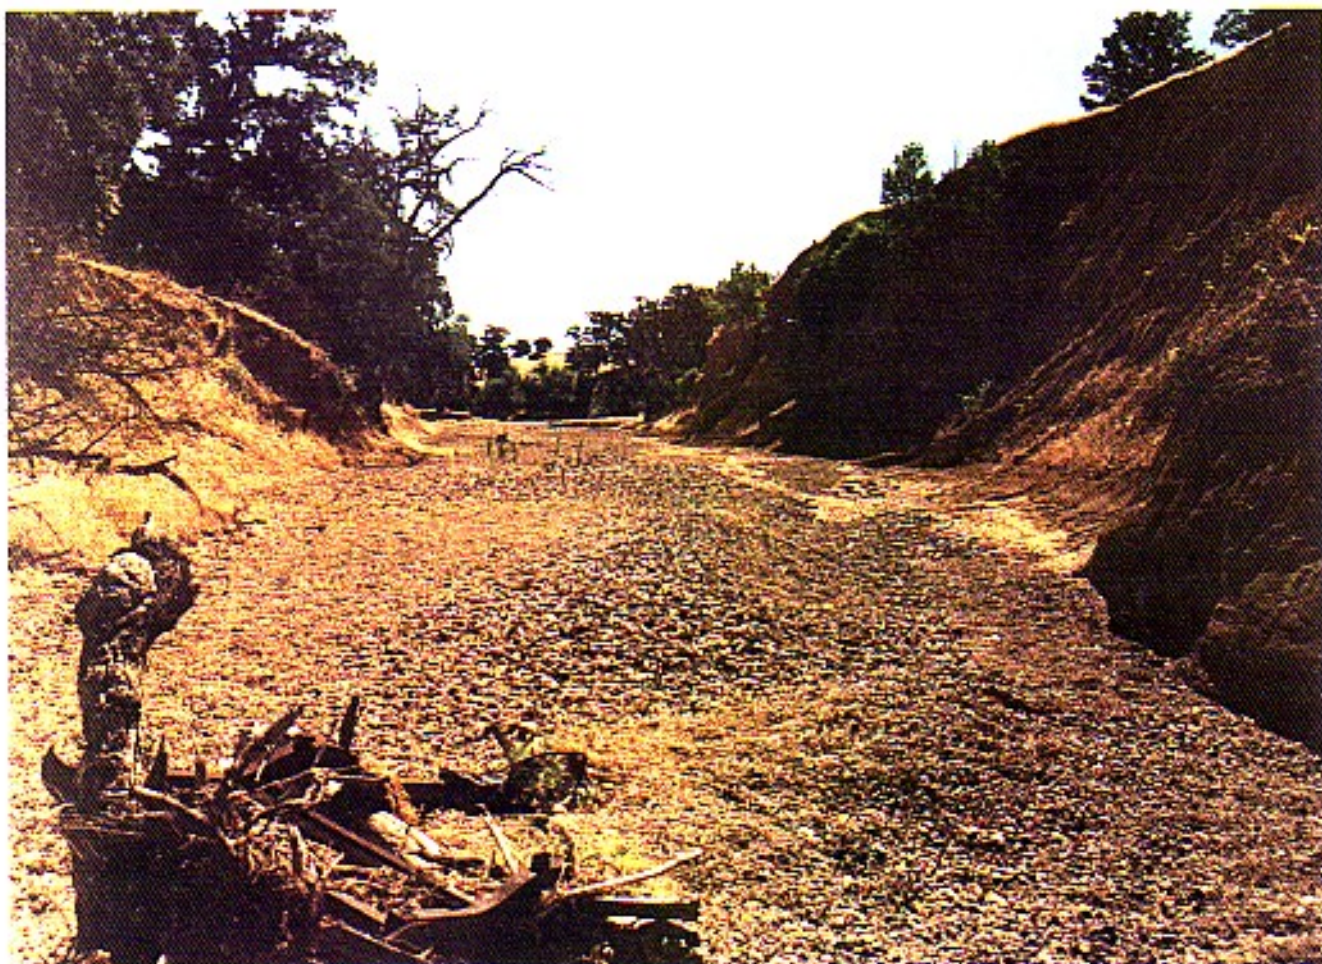
Photo 6. Most of Reeds Creek, such as here near the Hesse Road bridge, and the tributaries, are narrow and incised into the Quaternary Terrace deposits and the Tehama Formation.

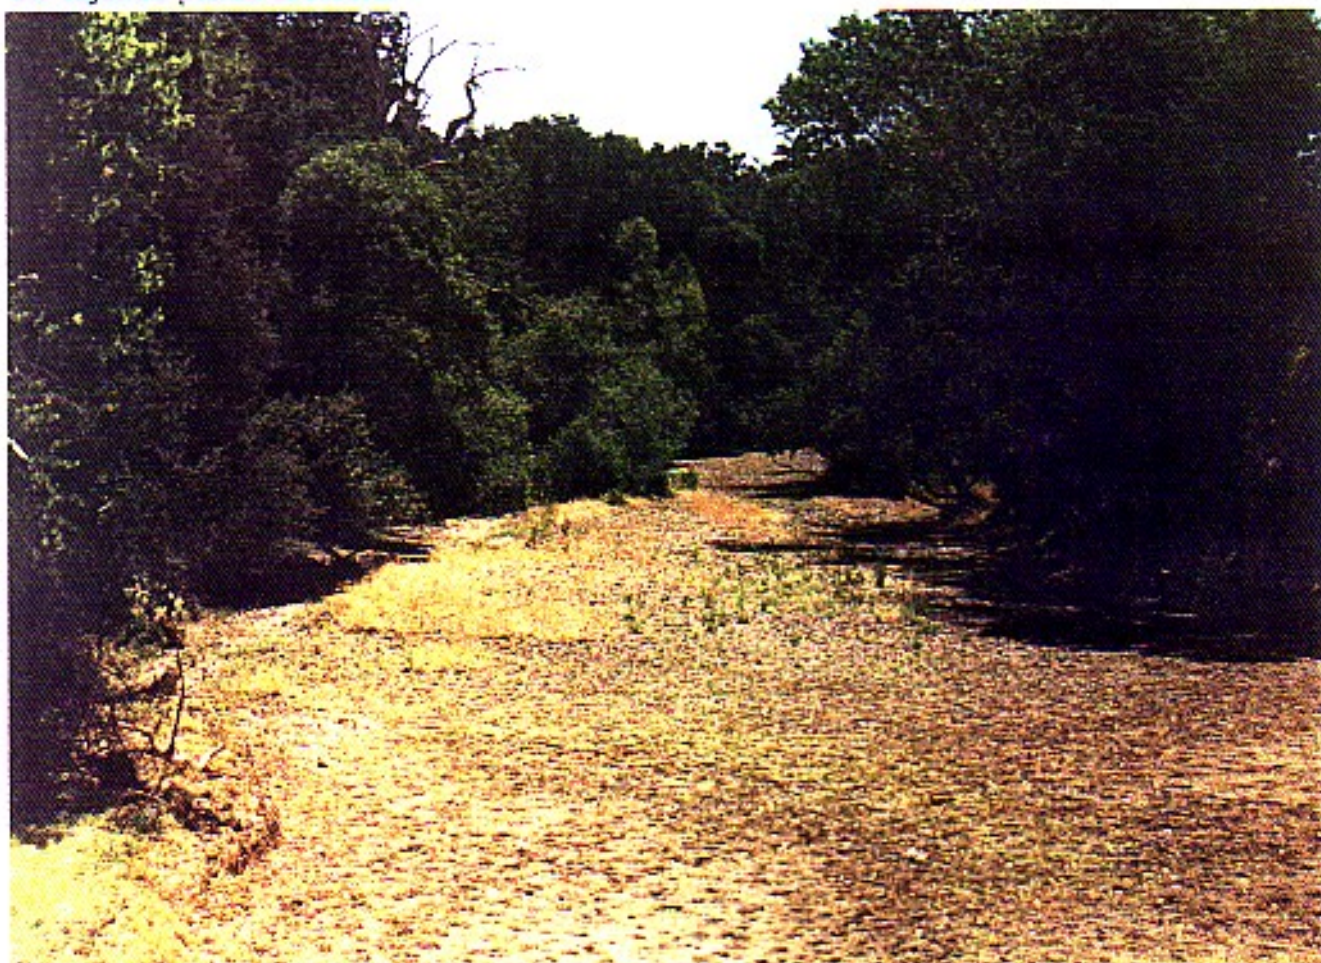
Photo 7. In places the lower part of Reeds Creek is heavily encroached by Riparian Vegetation. This is a result of low flows during the recent drought.

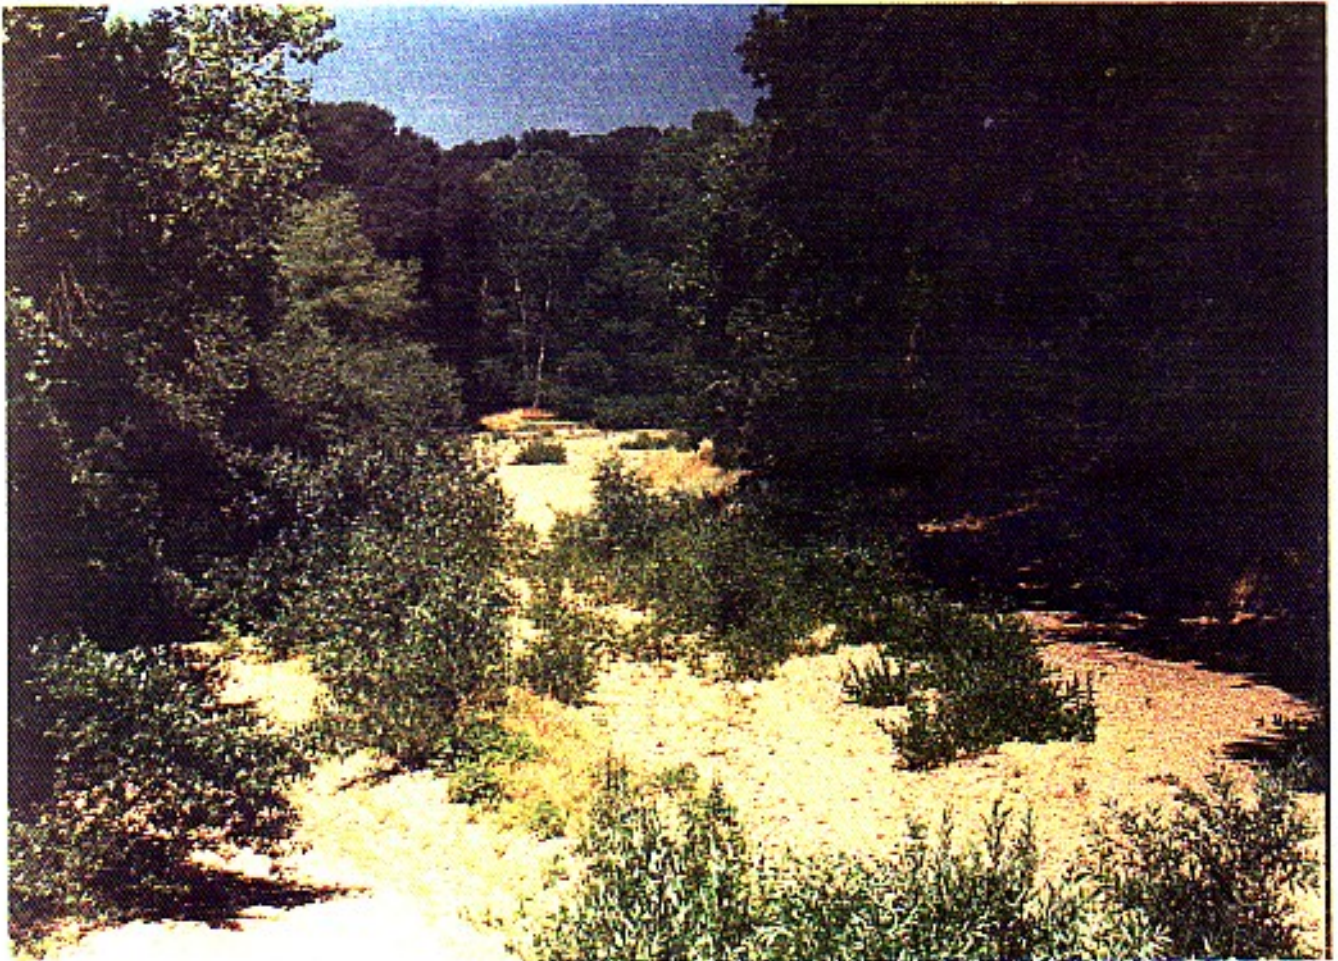
Photo 10. Live oak and riparian woodland occurs in narrow corridors along the larger streams.

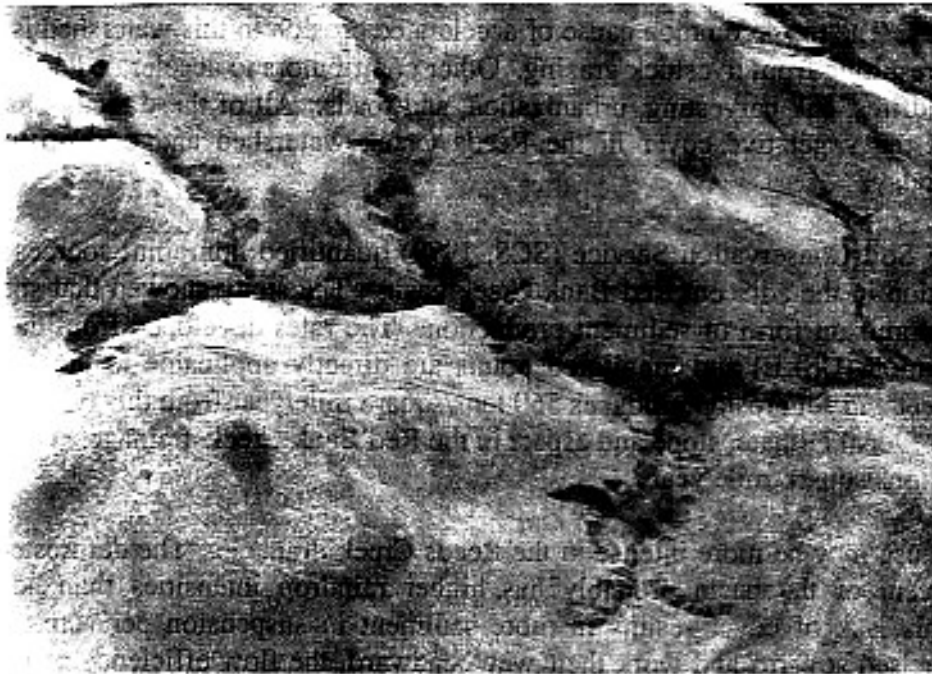
Photo 12. Gully formation is generally increased in areas that are cultivated, overgrazed or converted from oak woodland.

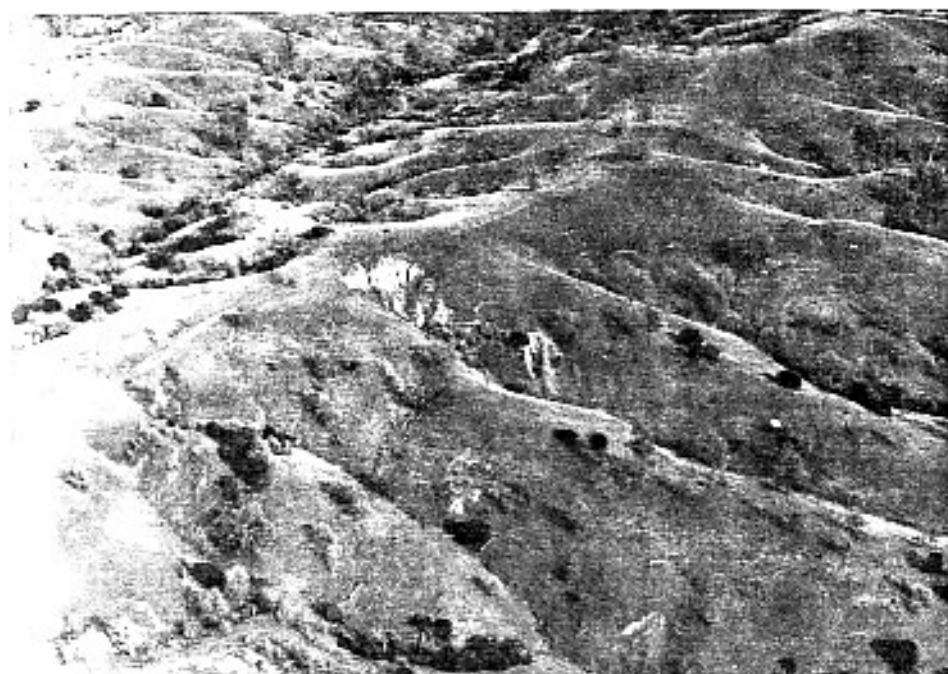
Photo 13. Landslides occur in localized areas in the upper watershed. Tree removal increases the likelihood of landsliding because of loss of root support.

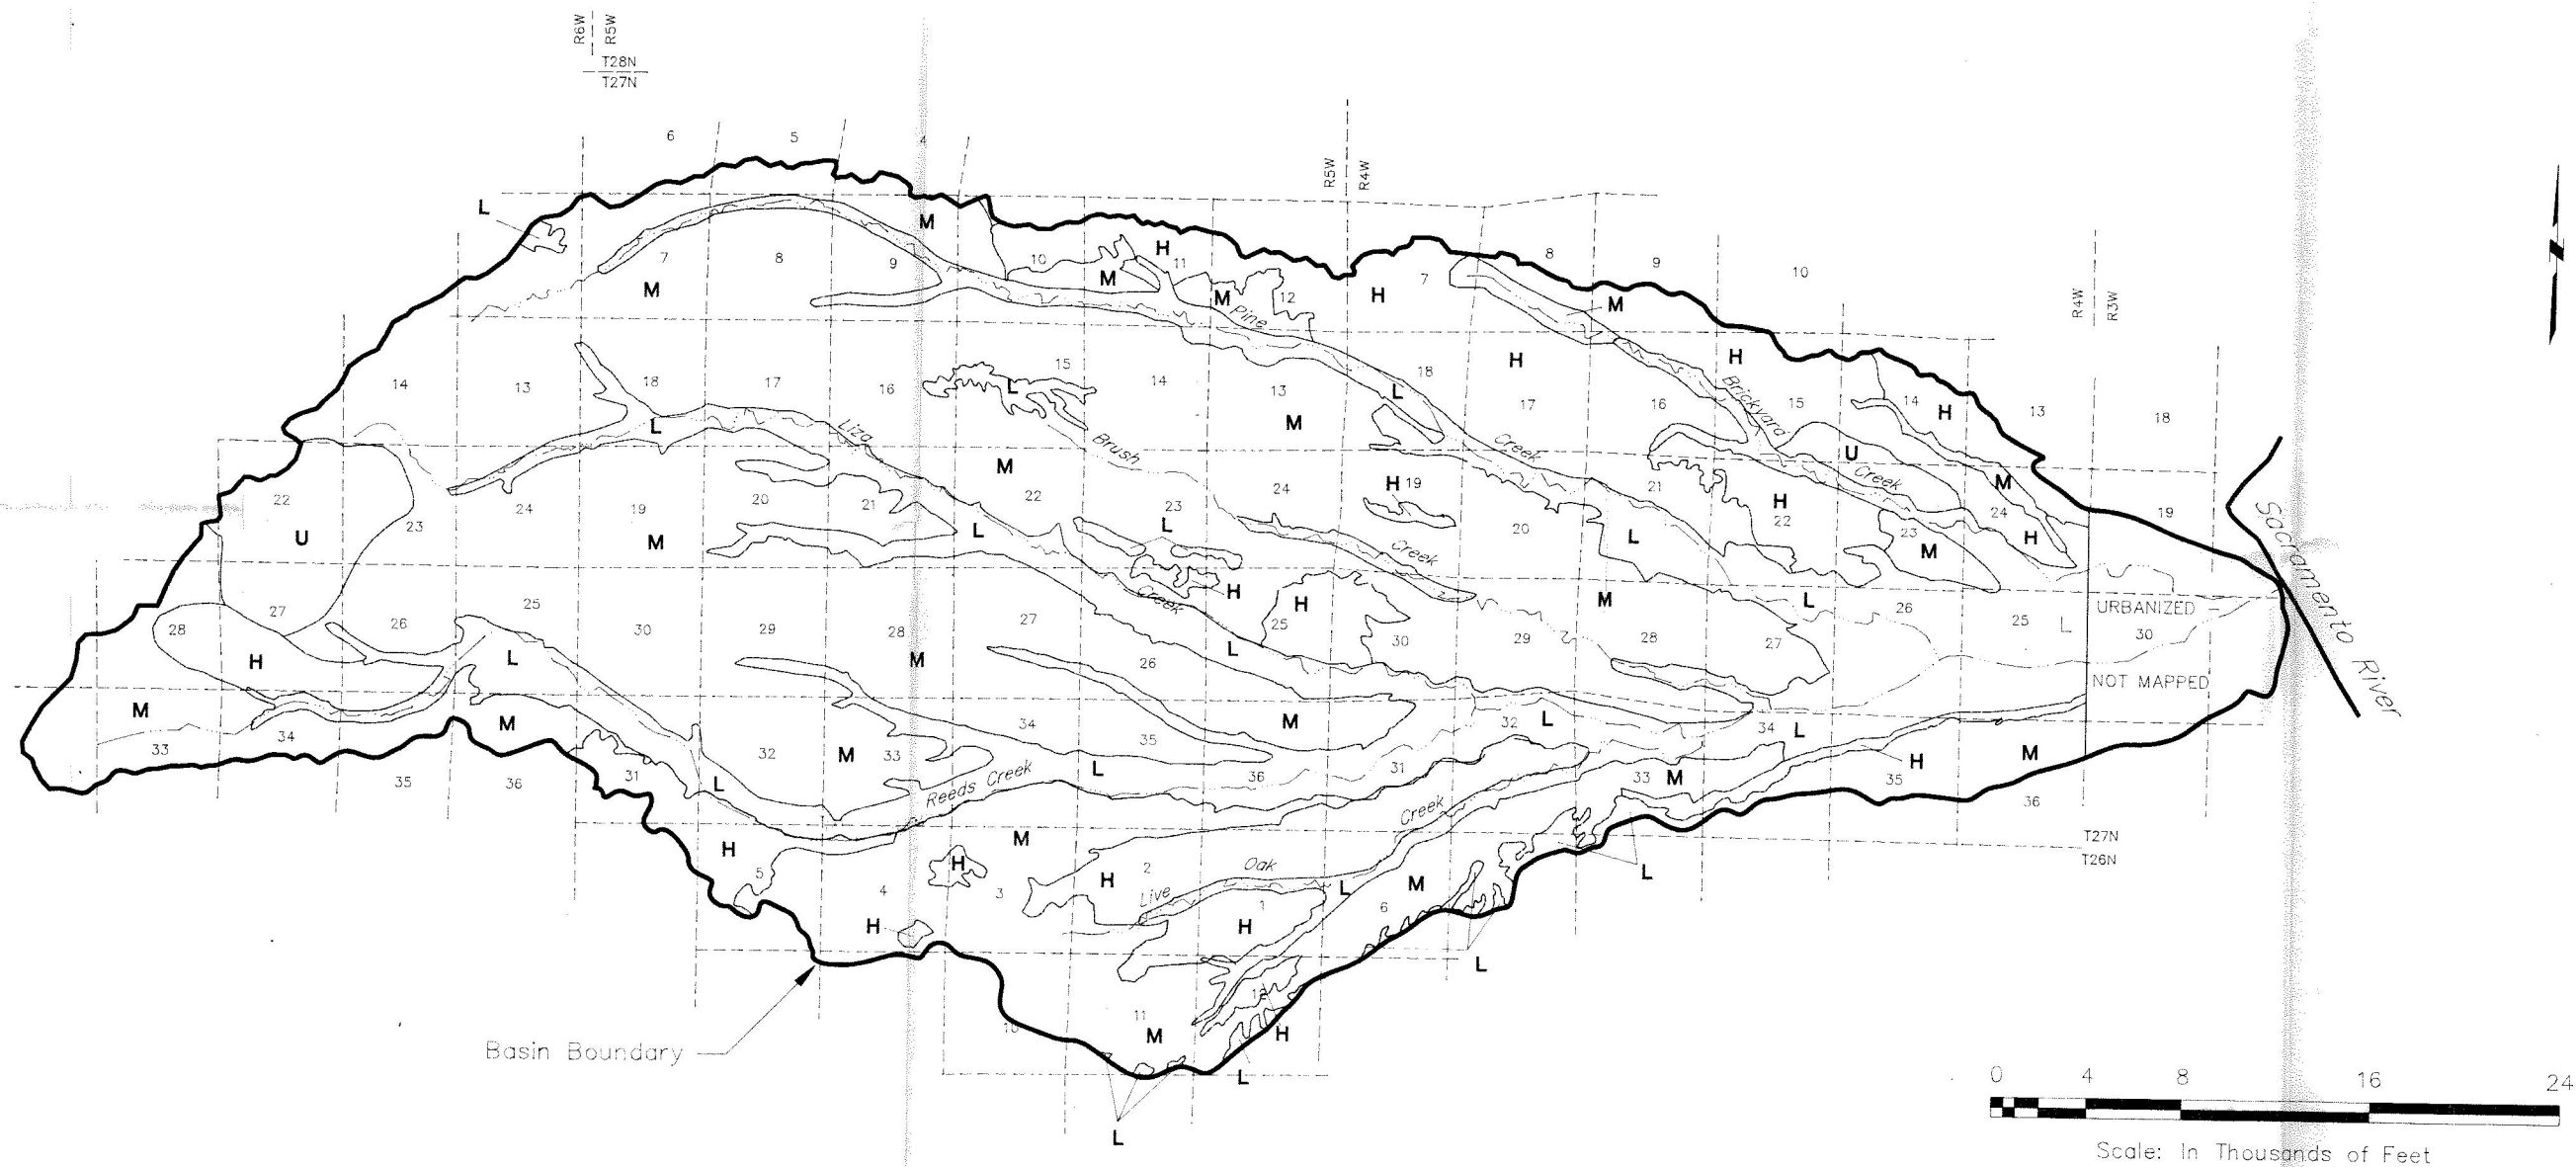
Erosion Hazard Ratings

Geologic and soils units were rated according to landslide and erosion susceptibility. An "Instability and Erosion Hazard" map (Plate 4) shows the unstable and erodible areas of the watershed.

geology, define the relative erosion hazard rating for the basin (see Plate 4). The major types of erosional processes in this basin are probably rill and gully erosion with some sheet erosion (SCS, 1979). A few landslides occur. Accelerated erosion occurs as rills and gullies in overgrazed areas, as rilling on unvegetated road and stream bank cuts, and as gullying downslope of road drainage ditches.
